HEALTH RISK SURVEY FOR GALENA AIRPORT, ALASKA:
AIR PATHWAY EVALUATION

Final Technical Report for Period 16-23 June 1993

AL/OE-TR-1993-0187

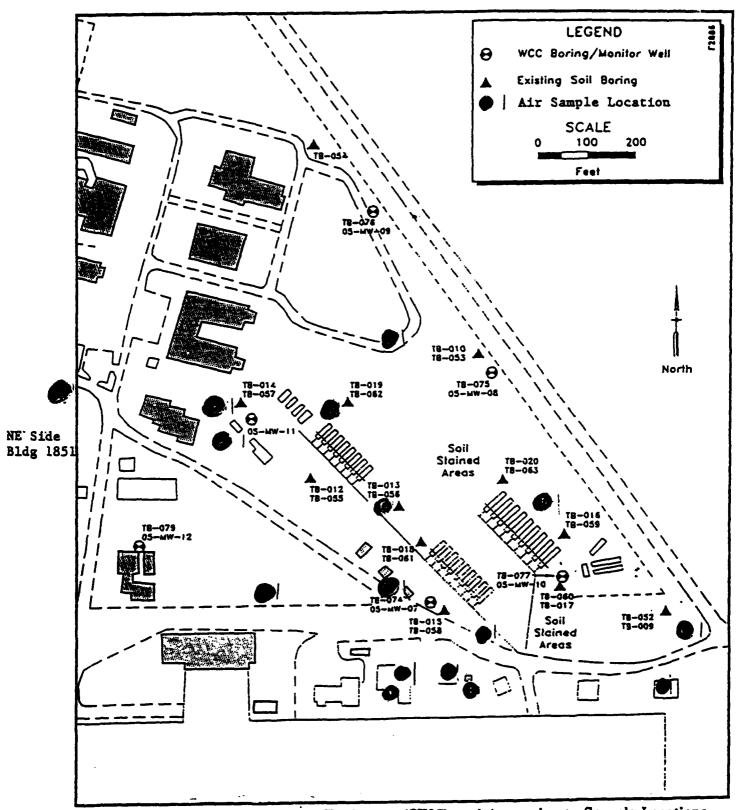
Figure A2. The POL Storage Tank Area (ST05) and Approximate Sample Locations, Galena AFS, Alaska (ZONE 2)

<u>Soil Gas - Conduit</u>. A conduit-derived soil gas measurement taken near MW04 (Figure A2 - site ID#2) signifies that the potential for volatilization may exist for the plume located in this area. Two other measurements taken W/SW of MW04 also read above zero, at 12.5 and 12 meter units. As expected, samples taken near the POL tanks indicated that volatilization was occurring in this area and that this area is a VOC emission source.

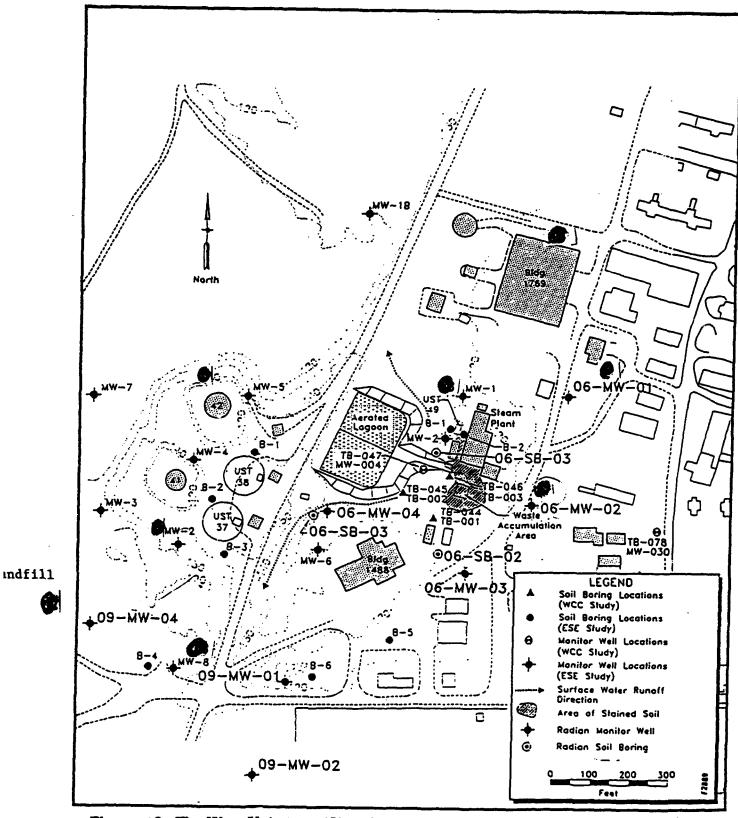
Figure A3. The West Unit Area (Sites ST09, ST11, and SS06) and Approximate Sample Locations, Galena AFS, Alaska (ZONE 3)

<u>City Landfill (Figure A3)</u>. The measurement taken in the landfill, located W of the ARPT property, resulted in a benzene concentration of 110 μ g/m³ and a toluene concentration of 380 μ g/m³. Ethyl benzene and xylene, although not quantified were below their recommended comparison levels. Both the benzene and toluene concentrations may be attributed to vehicular activity and the inability to prevent access. Unlimited access makes it quite possible to dump unwanted materials (including fuel oils) into the landfill. The landfill is used jointly by the AF, the state, and residents of Galena.

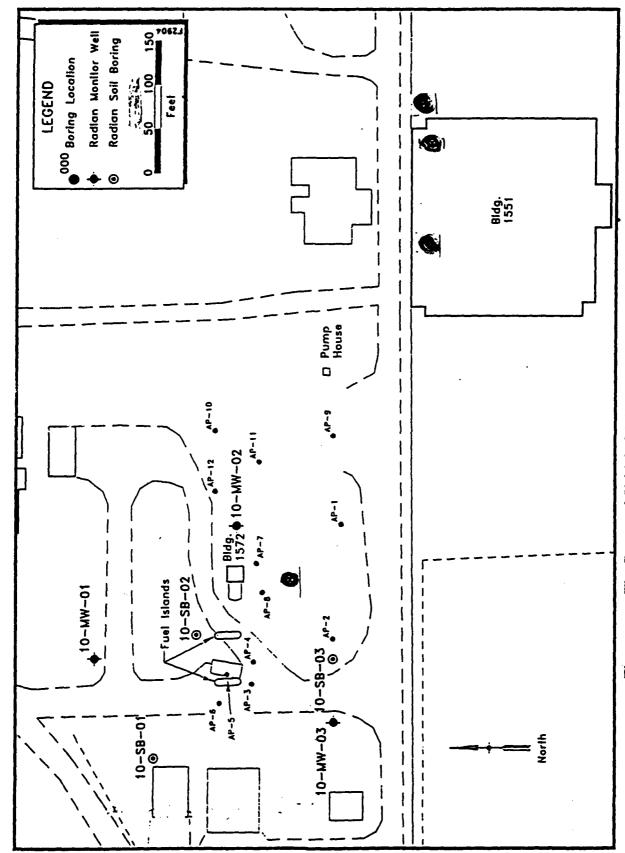
Figure A4. The Proposed Vehicle Maintenance Building Arca (Site 10) and Approximate Sample Locations, Galena AFS, Alaska (20NE 3 cont.)

On-Base Indoor Samples (Tables A1 and A2 - Figure A4). The only onbase indoor samples were collected from the CE office and in the E side of building 1551 (hangar). The CE office average benzene concentration was 4.1 μ g/m³, close to outdoor sample results from the same area. This result may be due to vehicular activity from within the hangar, aircraft activity outside the hangar area, ambient exposures from area (outdoor) sources, and/or a small diesel fuel leak in the building 2 days prior to sampling. The leak was discovered and repaired within 1 day. Photoionization detector measurements taken from the confined space below the leak area resulted in a total VOC concentration below the detection limit, 0.0 meter units. The measurement taken inside the hangar was not quantified, less than 7 μ g/m³.

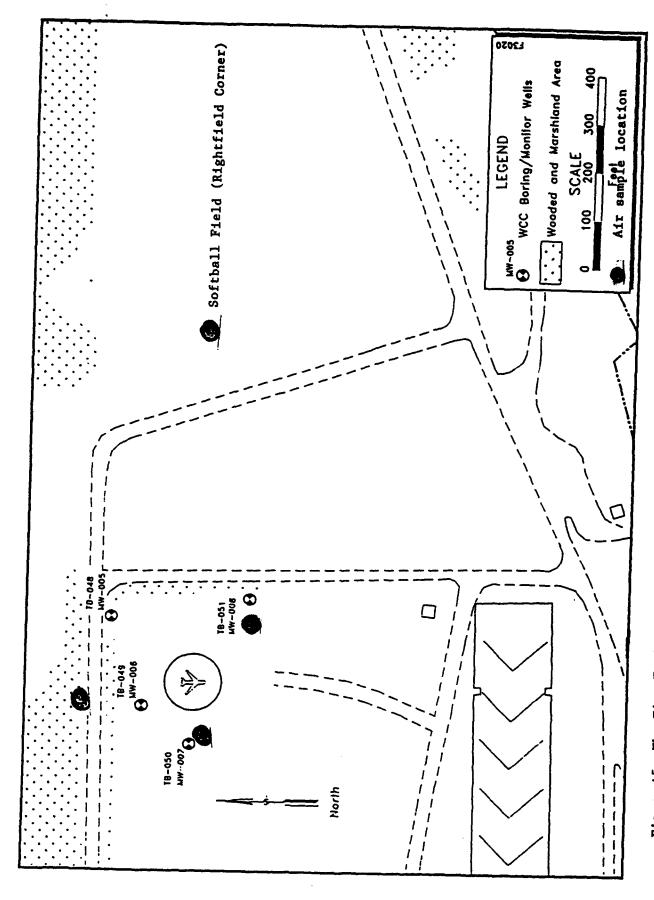
(ZONE 4) Figure A5. The Fire Training Area and Softball Field (Galena)

<u>Mock-up Plane</u>. The fire protection training area (FPTA) is in close proximity to the softball field where children play and these children may be attracted to the aircraft mock-up inside the FPTA.

There is no berm or fence surrounding the area that was once used for fire protection training. The FPTA is in close proximity to the softball field where children play and there is a slight possibility that these children may be attracted to the aircraft mock-up inside the FPTA. The pathway of concern is potential surface soil contamination. It is recommended that the mock-up plane be removed or that a barrier fence be placed around the FPTA.

- Ensure that all pipelines and tanks are periodically inspected, and leaks are repaired promptly.
- Remove the mock-up plane from the fire training area.
